POPPLETON HISTORIC STUDY

B-2549

| 199 | 15/16-22 | 1201-1215 W. Fayette Street |

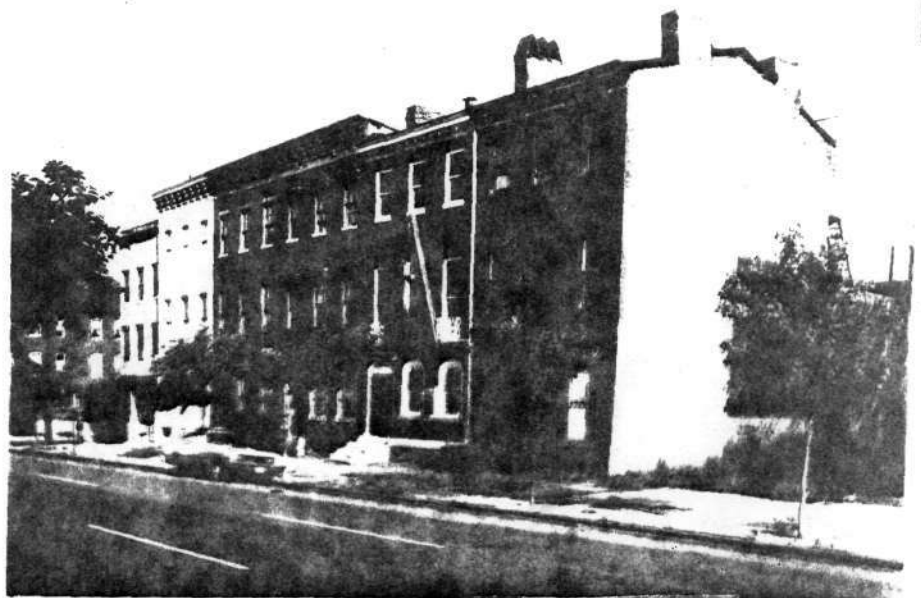
B-2549
1201-1215 W. Fayette Street
Block 199 Lots 015-022
Baltimore City
Baltimore West Quad.

Number 1201 is a very deep house which fills the whole of the 100' depth from Fayette Street to the alley. It has recently been formstoned and appears in good condition. There are shops at 22, 24 N. Carrollton; 26 appears to be an entrance to dwellings above.

Numbers 1203-1211 are well detailed houses of the late 1860's or early 1870's. Number 1207 is richer than the others because of the projecting lintels over the windows. Number 1211 is an early house to which a brownstone ground floor front may have been added. The damage to 1209 in its transition to a church, though partaking of "folk art" is ugly and drastic. It is, however, well-maintained, and so may be irreversible.

Lots at 1213 and 1215 have been cleared. The struggling street trees will do some good in another five years. The very wide sidewalk might be redesigned to incorporate some "soft" areas.
